# FATIGUE BEHAVIOUR OF A ROLLED AZ31 MAGNESIUM ALLOYS PREPARED BY EP AND BB CONDITIONS

**Abstract:** Rotating bending fatigue tests have been performed using smooth specimens of a rolled AZ31 magnesium alloy in laboratory air at ambient temperature. Fatigue strength and characteristic was evaluated and fracture mechanism was discussed on the basis fracture surface analysis. Electrical polishing (EP) as well as deep rolling (ball burnishing (BB)) U-notched specimens were performed on two groups of samples, to evaluate optimum conditions for fatigue life. The microstructure and tensile properties of roll cast (RC) Mg- 3% Al- 1% Zn (AZ31) was investigated. The fatigue strength of 107 cycles around 100 MPa for deep rolling while it was around 40 MPa for Electrical polishing. It was very important to understand the effect of (ball burnishing (BB)) conditions on the hardness of the surface through to the core. The two procedures improved the fatigue performance, but better improve in results were found in ball burnishing. The growth of small cracks initiated at the surface coincided with the FCP characteristic after allowing for crack closure for large cracks, but the operative fracture

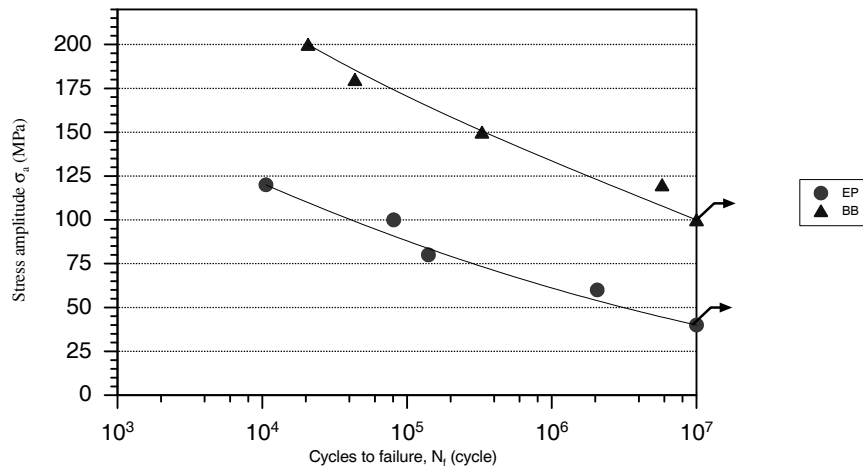
**Fig.2.** S-N curve for rolled AZ31 at EP,BB conditions, rotating beam, R=-1, 50Hz.

S/N curves for the EP and the BB specimens in laboratory at a stress ratio of -1 and frequency of 50 Hz (rolled magnesium alloy) in laboratory air is shown in Fig. 2. In this figure, for comparison purposes, the S–N curves of the EP and BB specimens are shown respectively. As seen from the figure, the fatigue life of the rolled magnesium alloy of EP specimen is relatively shorter than that of BB specimen. The extent bending in the S–N curve is gentler in the BB specimens than in the EP specimen. Next let us compare the S–N characteristics of the EP and BB specimens. There are great differences in the fatigue lives and in the fatigue limits, especially at higher stress amplitudes, there are differences in the fatigue lives.

4. Subsurface crack initiation occurred at applied stresses at 60 MPa. At BB condition but it can be seen for both 80 and 100 MPa stress for EP condition. The S-N diagram is shown in Fig. 2. It is well known that fatigue limit does not exist in non-ferrous alloys, thus fatigue tests were continued until  $10^7$  cycles. At EP condition  $\sigma = 40$  MPa, fatigue failure did not occur, but non-propagating cracks were observed on the specimen surface. As can be seen in the figure, the present Mg alloy seems to possess a definite fatigue limit, which may be related to the existence of non-propagating cracks. The fracture mode depending
